TCI Grand Turk Biorock Projects Before and After Hurricane Ike

Lucy Wells, Fernando Perez, Marlon Hibbert, Luc Clerveaux
Department of Environment and Coastal Resources,
Turks and Caicos Islands
&
Thomas J. Goreau
Global Coral Reef Alliance

Grand Turk Biorock® projects before and after Hurricane Ike, which damaged or in some cases destroyed 80 % of all buildings on the island in September 2008.

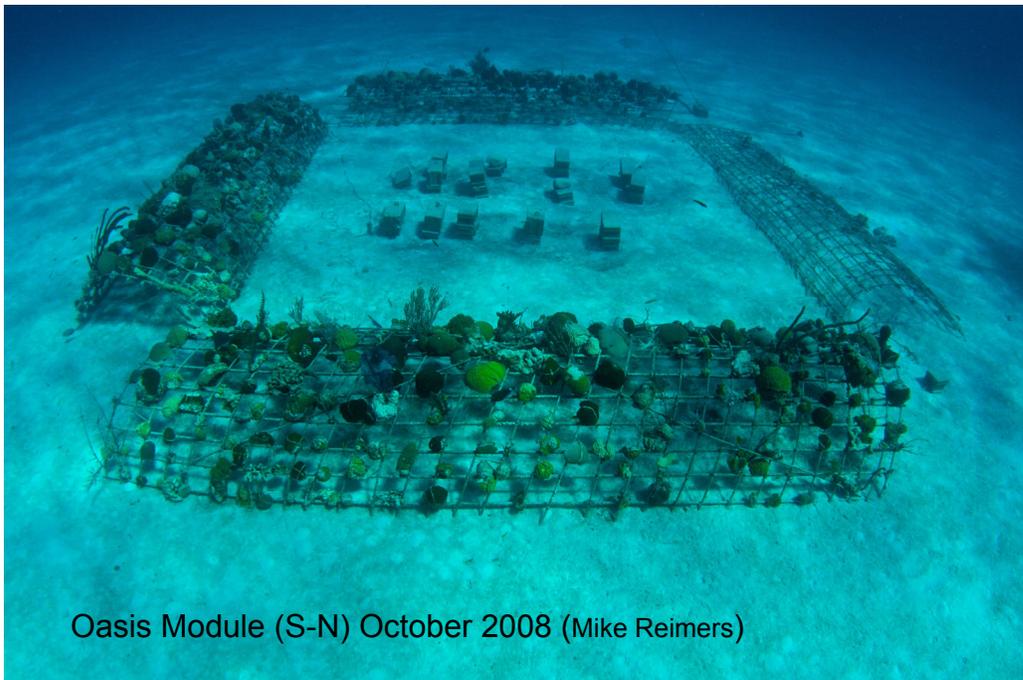
Oasis Module (S-N) October 2008 (Mike Reimers)

N.B. After Hurricane Ike the structure on the right, which had not been welded, and whose tie wire had rusted while it was without power, sagged. The corals were removed and later transplanted onto a new welded module placed above the old sagged one, which remains connected and growing.
