Biorock Electric Reefs Grow Back Severely Eroded Beaches in Months

Thomas J. F. Goreau ^{1,2,*} and Paulus Prong ^{2,3}

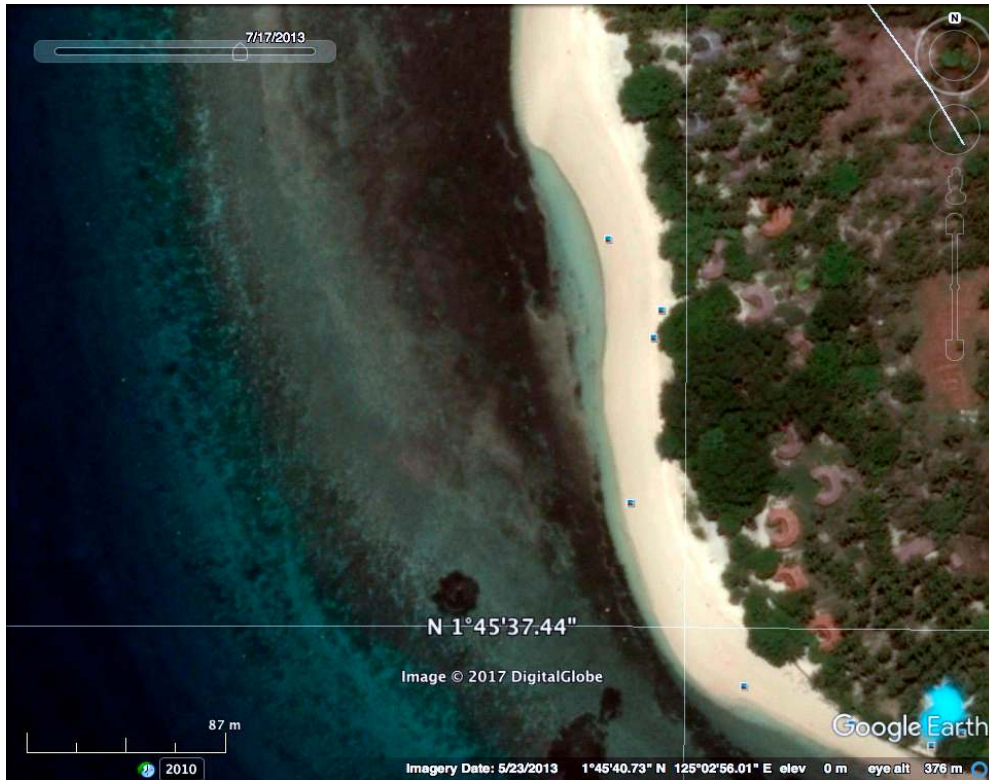
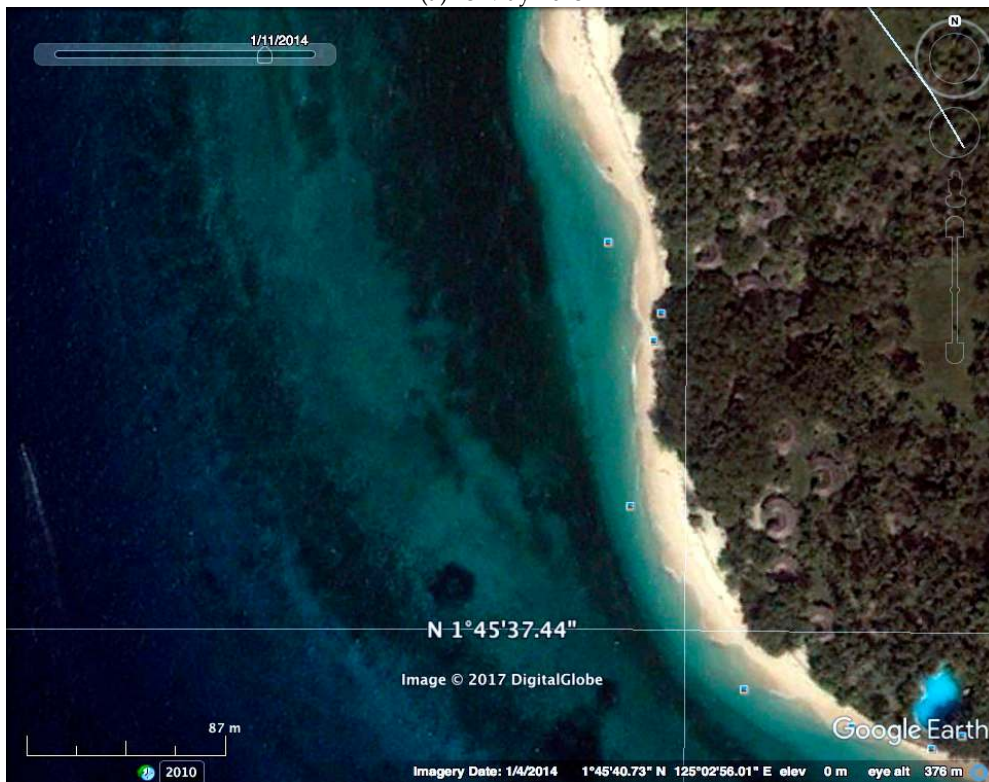
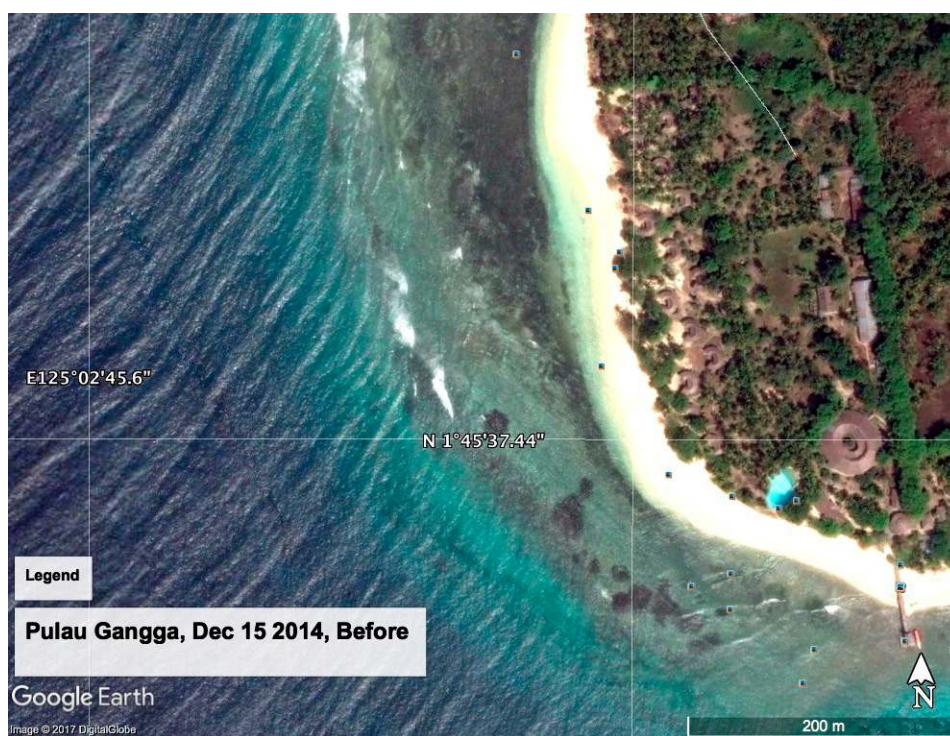
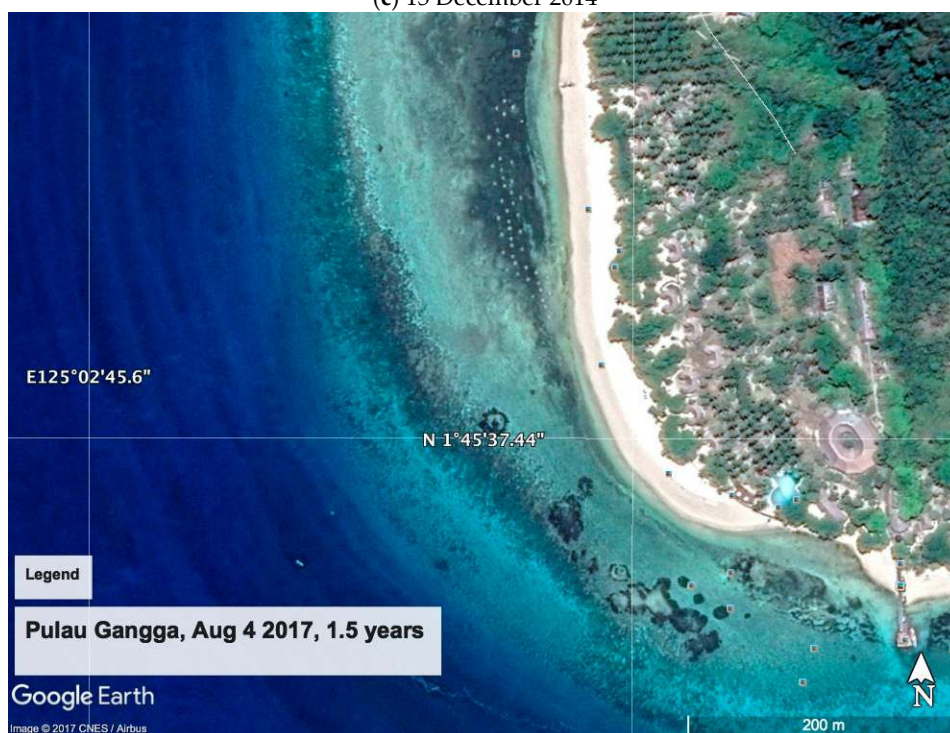
Figure 2. Erosion of the beach prior to the project. Google Earth images from 2013 (a) and 2014 (b) showing short term changes in the beach before the project, the last available image taken near low tide a year before the project began in early 2016 (c), and the first image after the project, taken near high tide 1.5 years after (d). Notice the cores of the Biorock Anti Wave modules as white spots in the seagrass off the regenerated beach. Beach erosion beyond the project near the pier at the south was caused by storm waves from the southeast and longshore drift sand blockage by the solid rock pier. Waves from the northwest shown in (c) are typical during erosion of this westward facing beach. Note the row of pavilions (dark spots) on the edge of the beach erosion scarp and brown dying trees with roots exposed in (c) and how in (d) the roofs are now hidden by new leaf canopies due to prolific tree leaf regrowth after sand buildup around their roots.

Pulau Gangga, North Sulawesi, Indonesia, has suffered progressive beach erosion. The index maps show its location on various scales (Figure 1a–d), and Google Earth images show the rapid erosion of the beach between 2013 and 2014 (Figure 2a,b). The site is outside the typhoon belt because it is close to the Equator, but it is affected by both the Australian and Indo-China Monsoons. From around December through May the winds and waves are usually from the southeast. A strong southward tidally-modulated current normally sweeps sand from north to south at the site.

The formerly wide sand beach had largely washed away by late 2015, leaving an erosion cliff about 1.36 m high along the shore, with trees falling into the sea, and beach pavilion buildings have had to be repeatedly torn down and moved inland. In front of the 200 m of severely eroded beach we built 48 Biorock Anti Wave reefs in a staggered design to dissipate wave energy before it hits the beach. The time of installation, January 2016, was just before the monsoon season when erosion takes place on this beach, and was done as fast as possible before waves made installation difficult.

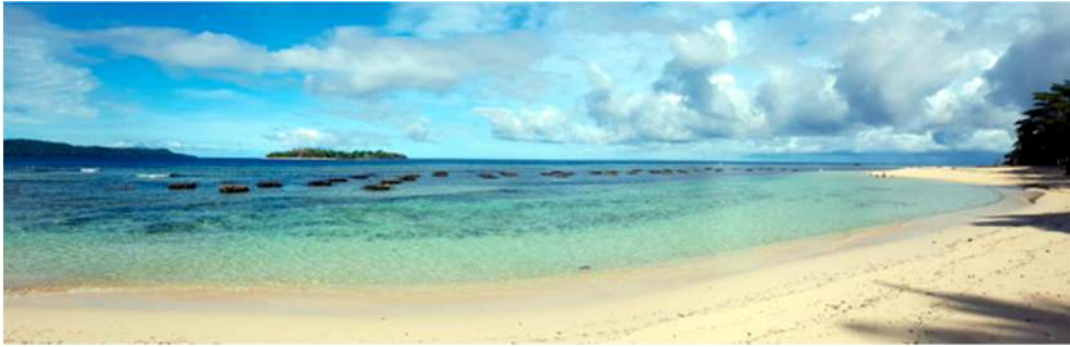
Figure 3. Soon after start of the project, at low tide (wide angle image). The tops of the reef restoration structures are clearly visible. The eroded curve is the area where the beach grew back.

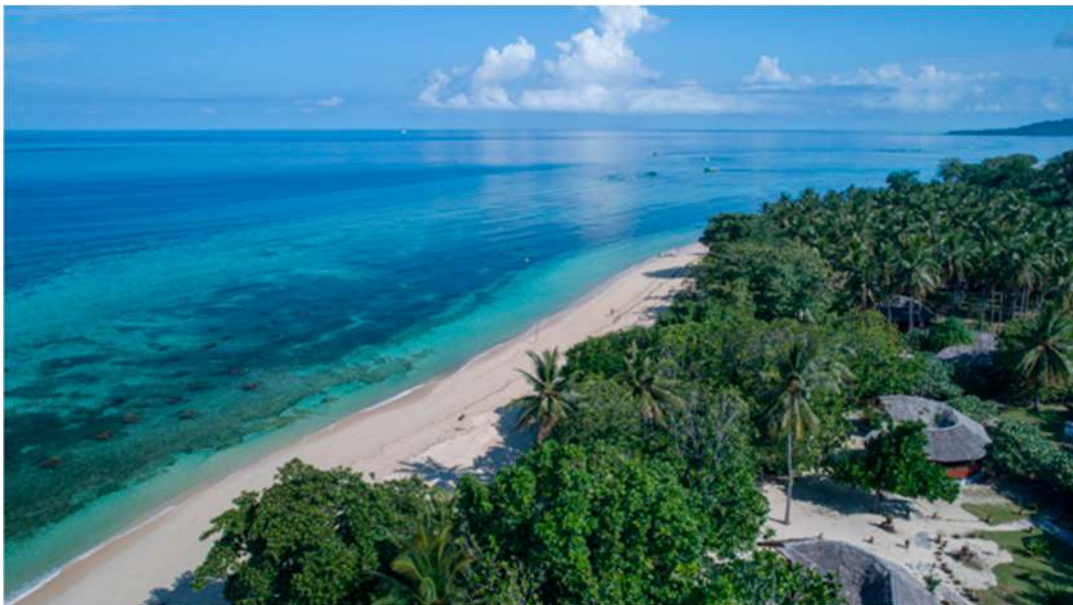
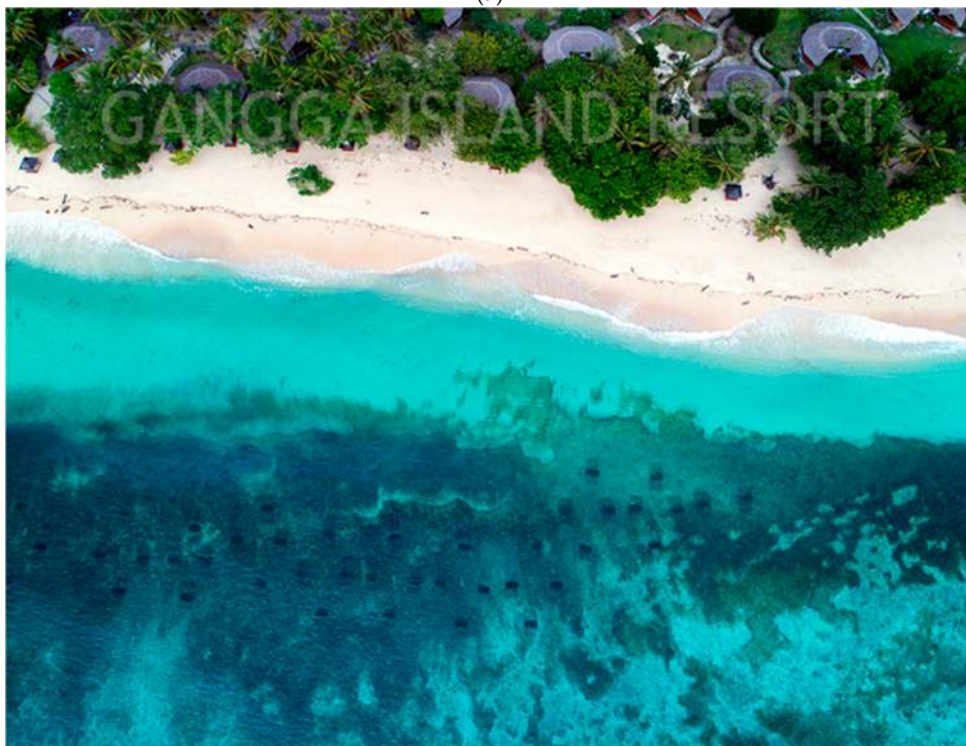
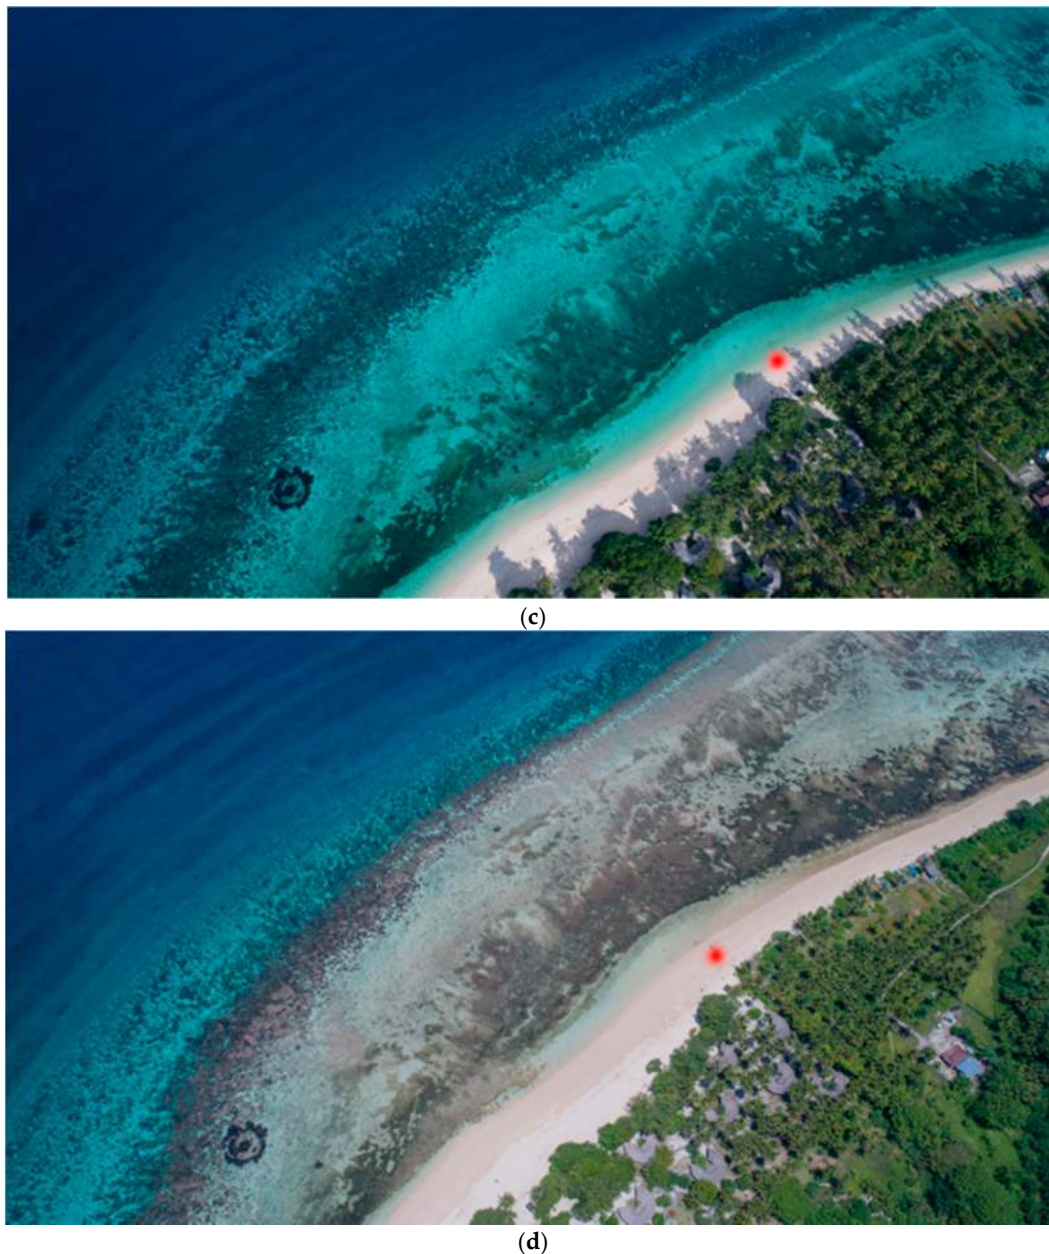
Figure 4. Aerial views, oblique at low tide (a) and vertical at high tide (b) on 12 March 2017, fourteen months after the installation, showing the Biorock Anti Wave structures (dark spots in sea grass beds). The northern edge of the project, on the same day at high (c) and low (d) tides. The Red spot in the last image two images is the northern limit of the project.

48 Biorock Anti Wave reefs were deployed in the sea grass beds in front of the eroding beach in January 2016. They were arrayed in twelve groups of four, each group powered by a single power supply located 100 m away on land, connected by electrical cables dug into the sand (Figures 3 and 4a–d). They grow thickest at the bottom, and thinnest on top. The bottom 10–20 cm of the structures were always submerged at low tide, but above this they were exposed to the air for various periods, depending on the tidal cycle. Since structures grow only when and where submerged in salt water, the bottoms are always growing, while the top grows only when submerged, about half of the time. The gabion baskets were deployed in a grid pattern (visible from aerial images below) at low tide in shallow sand, seagrass, and coral rubble.

The core of each structure was a double gabion basket, 1 m × 1 m × 2 m with the long dimension parallel to the shore. These were placed on the shallow sea floor at predetermined sites, with the long axis parallel to the shore, and filled in with rounded river stones (largely in the 20–50 cm size range). At the start, the rocks had clean surfaces with nothing growing on them. The gabion baskets were overlain with standard welded steel mesh bars used in local construction, spacing 15 cm, dimensions about 2.1 m by 5.4 m. These sheets were curved into an arc to fit over the top of the gabion basket, with the long dimensions at right angles, so that the long axis of the arc was perpendicular to the shore, oriented into the waves coming over the shelf edge coral reef. They were welded across at the base with support rebars and vertical bars to strengthen them. Each unit was carried by four people at low tide, placed over a gabion basket and wired to it with hose clamps and binding wire. The growth of minerals over the steel cement it firmly to any hard rock bottom, and cement sediment around the bases on sand or mud, firmly attaching the structure to the bottom. The structures sit on the bottom under their own weight and that of the rocks they contain.

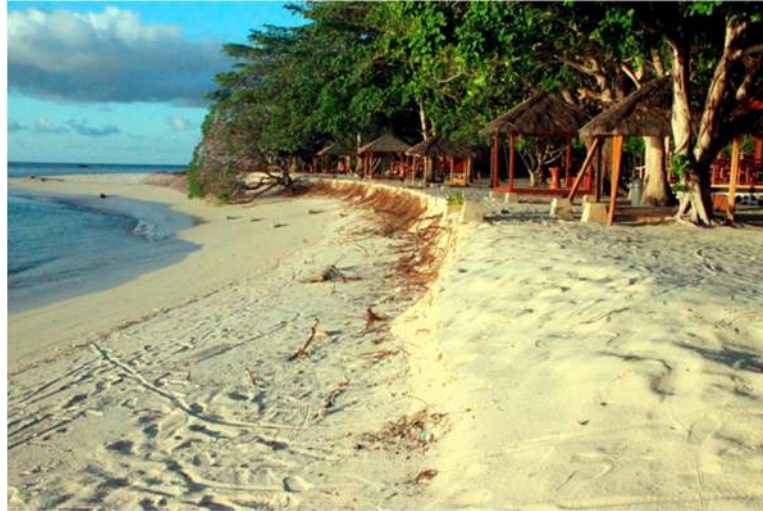
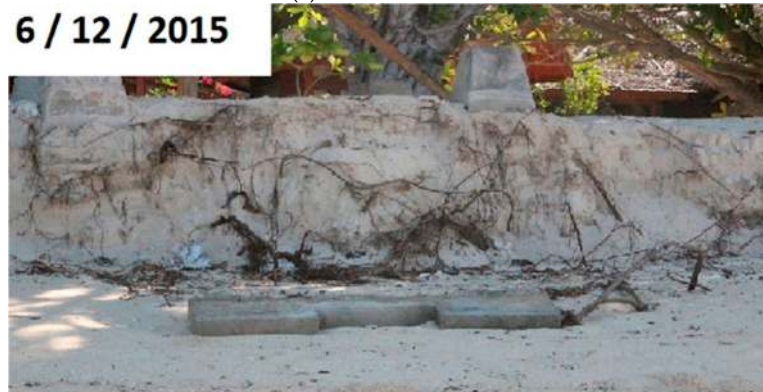
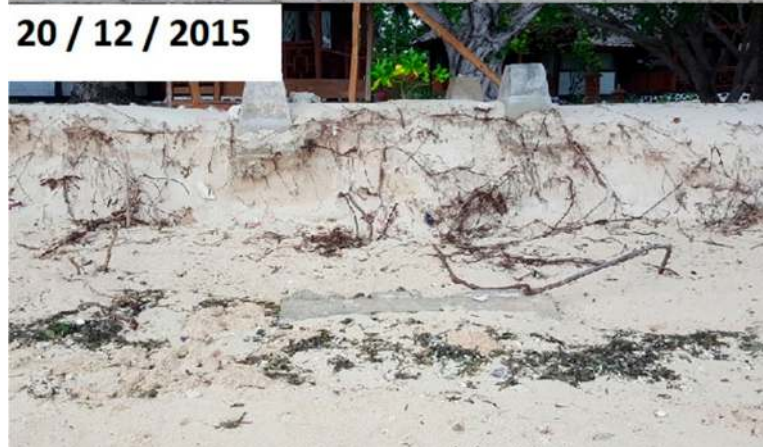
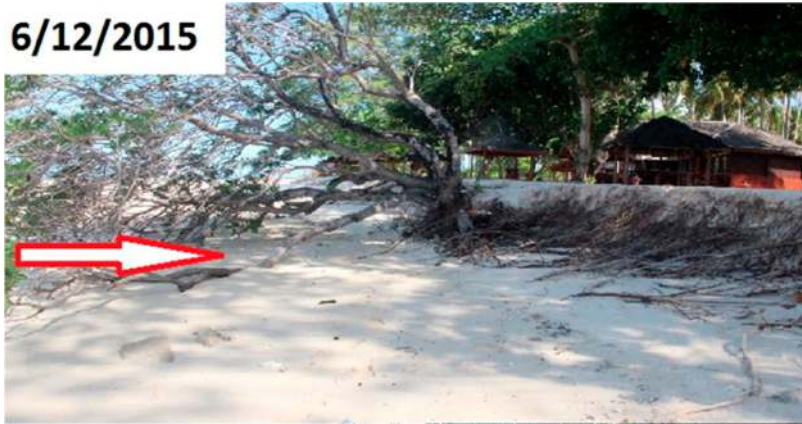
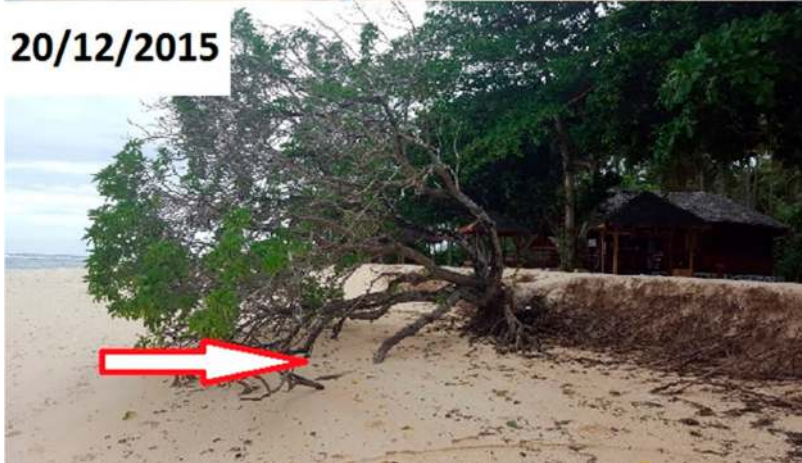
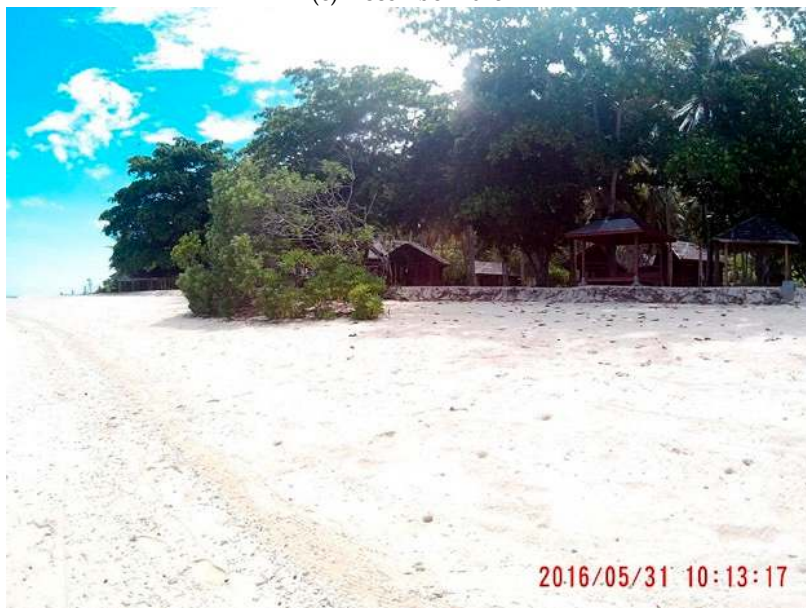
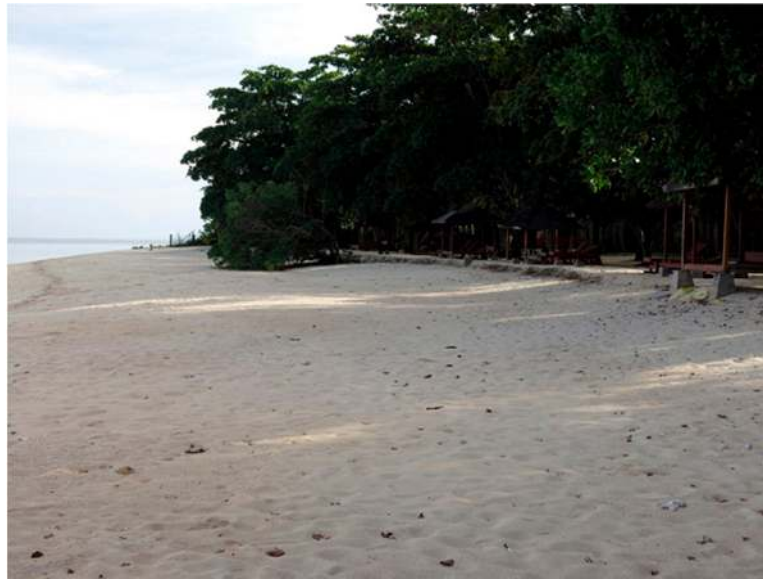
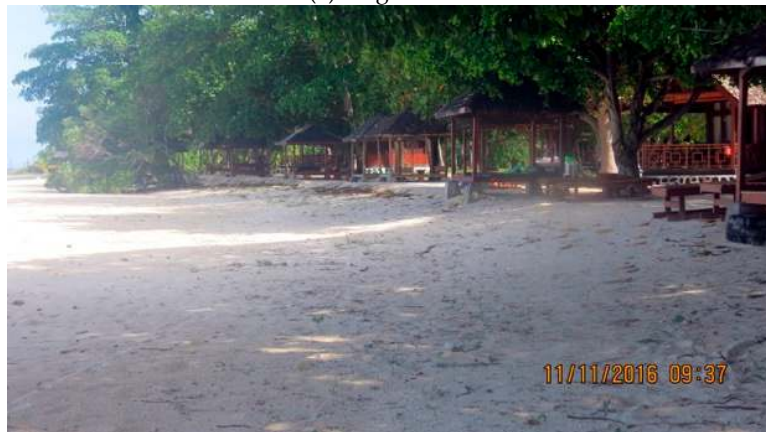
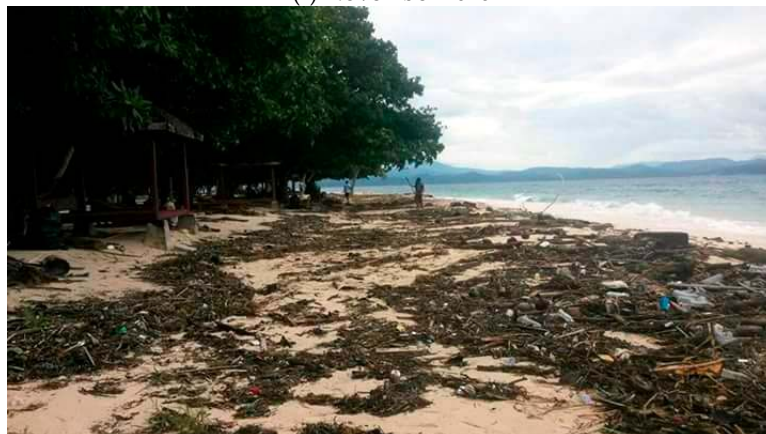
Figure 5. Before & after photos of beach taken at various times: (a) November 2015, beach looking north two months before start of project, tree falling into the sea and roots exposed at beach erosion scarp, (b) December 2015, one month before project, 1.36 m high erosion scarp and foundations of beach pavilions about to collapse near center of beach, (c) December 2015, one month before project, large old tree collapsing into the sea, leaves dying, roots exposed, (d) May 2016, 4 months after project installation, lower branches of fallen tree buried in new beach sand growth, roots buried, new growth, (e) August 2016, seven months after, (f) November 2016, ten months after, (g) January 2017, Twelve months after, soon after a severe storm, looking south. Most of the beach grew after the storm, even though this was the sort of event that had caused heavy erosion in the past. The south end, shown here, was worst affected.

The speed of beach regrowth astonished local residents. The formerly concave beach, ending in an eroding cliff, is now convex in its profile and growing. Large trees that had been dying after sand washed away, exposing their roots to sea water, have leafed out new canopies since the sand built up around their roots.

By the time of the first beach profile measurements the eroded beach had almost completely grown back and the erosion scarp, 1.36 m tall, was reduced to about 10 cm. About 80% of the beach grew back in less than 3 months and has continued to grow ever since, even during strong storm conditions that in the past caused severe erosion. Over the course of a year the beach has increased in height by more than a meter, and in width by more than 15 m, over a two hundred meter length, a conservative estimate of an increase of beach sand volume of 3000 cubic meters. Most of the gains occurred in the first two months, but have continued since (Figure 5a–g).

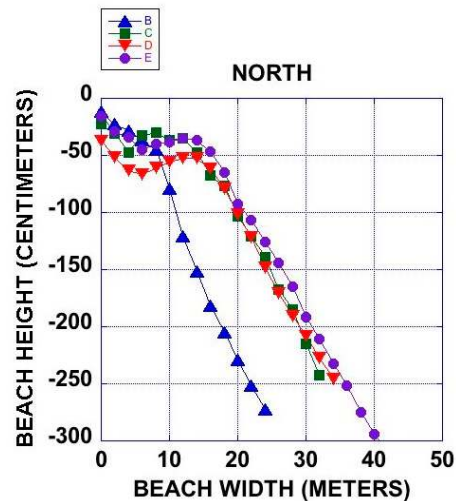
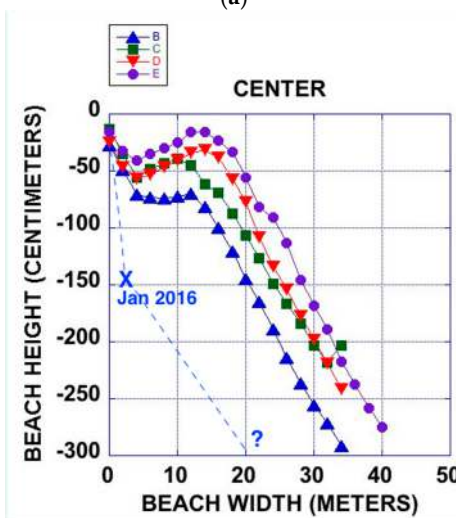
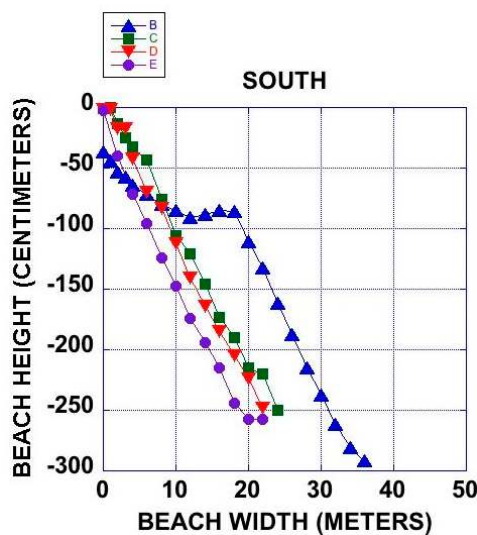
Figure 6. Beach profiles, measured at different times for the north (a), center (b), and south (c). The Zero reference datum for the central profile is the top of the concrete pillar foundation at the left of the December 2015 photograph. A 1.36 m vertical cliff stood at what is now the zero distance, based on measurements from photographs. Dates of measurements: X and dashed line estimate from January 2016; KEY to symbols: B upward triangle, 21 September 2016; C square, 11 January 2017; D downward triangle, 11 March 2017, E circle, 10 July 2017.

Beach profiles were measured using the U-tube water level measuring method [32]. They are estimated to be accurate vertically to about a millimeter, and horizontally to about a centimeter, by repeated measurements. The beach profile before the start of the experiment was estimated from photographs taken before and after from the same positions with common objects of known size in the images for scale. The accuracy of the pre-project beach profile estimate is thought to be about 10 cm vertically and one meter horizontally. Unfortunately, the apparatus for making rapid and accurate beach profiles was not built until September 2016, eight months after the start of the project. A second set of measurements was made in January 2017, a year after the start of the project, after a severe storm and at several more intervals since then. Initial beach profiles were estimated by measuring the height of the erosion cliff at the start of the project using the measured height of concrete foundations as a scale.

The beach growth in the first year was wider at the south than at the north. But there were interesting differences after a severe storm in early January, which caused some erosion of the southern end of the beach, while there was substantial growth of the central and northern sections. Since then the center and north have continued to grow, while the south has continued to erode slowly (Figure 6a–c).

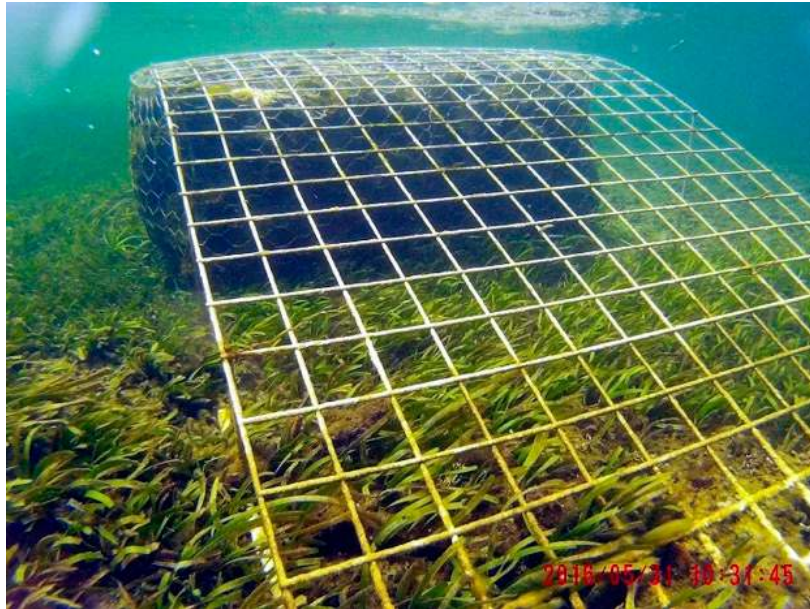
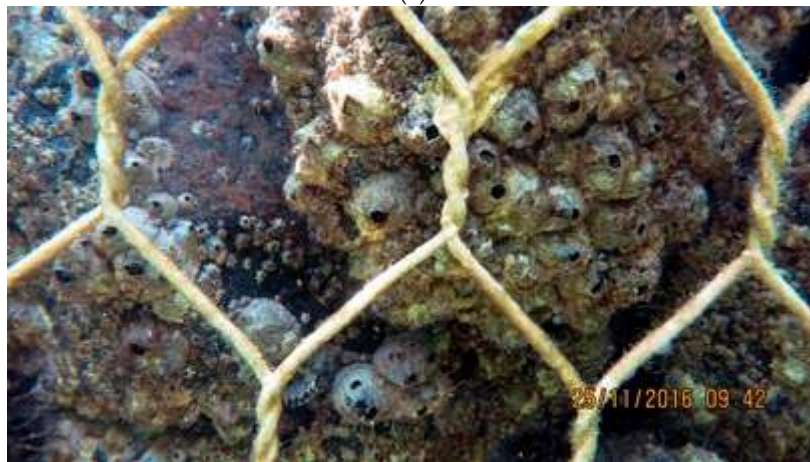
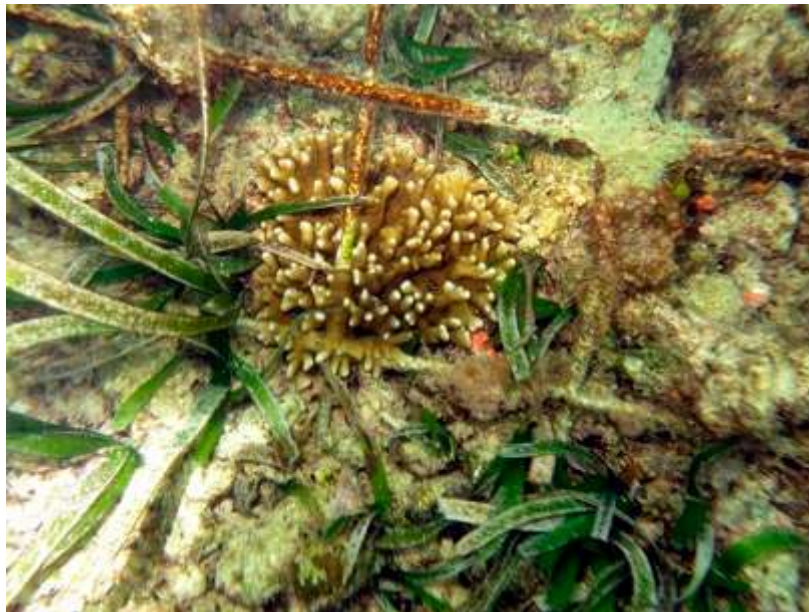
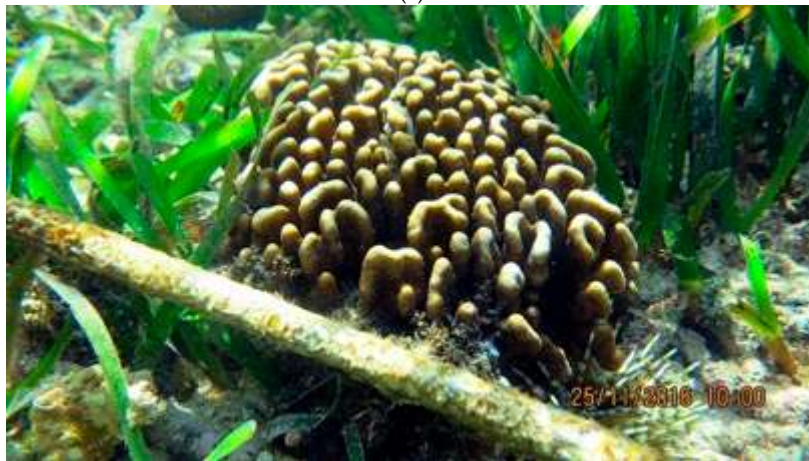
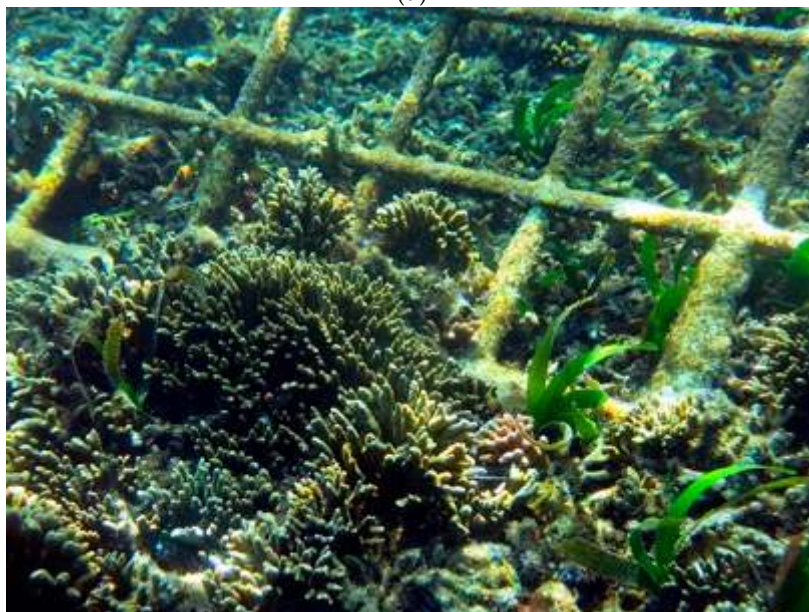
Figure 7. Underwater images: One end of a Biorock Anti Wave structures at high tide soon after installation (a), growth of barnacles over smooth river stones inside the gabions (b), examples of rapid growth of corals, sea grasses, and other organisms under, over, and around their bases (c–e).

There has been prolific growth of hard and soft corals all over the bases of the structures and in intervening areas (Figure 7a–e), prolific growth of sea grasses all around them, dense settlement and growth of barnacles, mussels, and clams on the rocks in the core of the BAW structures, and a rapid increase in juvenile fish and echinoderm populations. In addition, there has been prolific growth of sand-producing calcareous green and red algae around and between the structures.

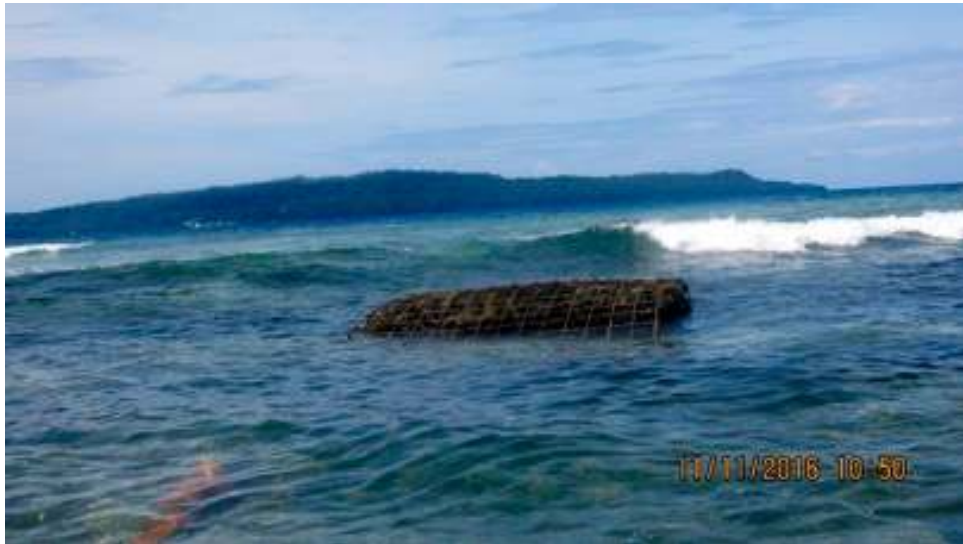
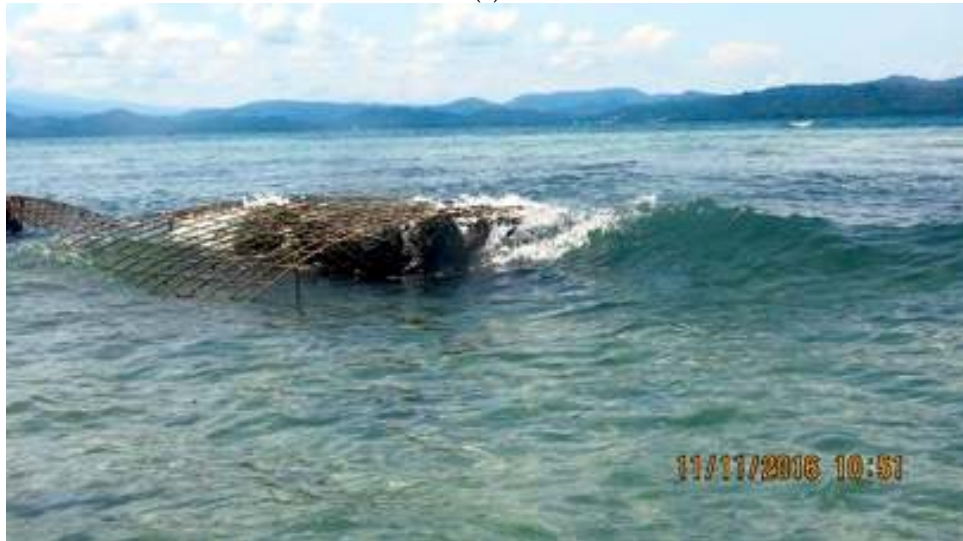
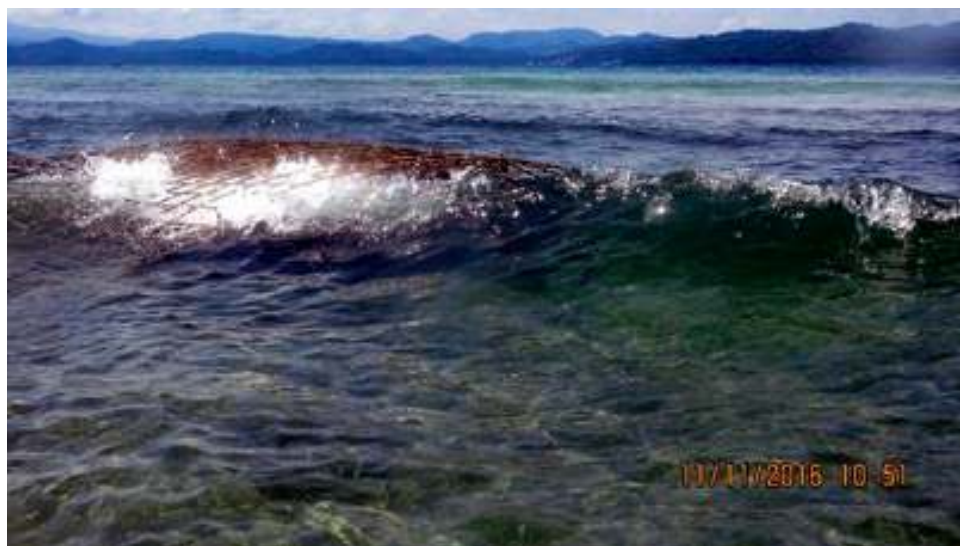
Figure 8. Diffraction of energy. Incoming wave energy dissipated by interaction with structure these photographs were taken in rapid succession, the middle picture appears brighter because of break in the clouds, and the photographer moved between the first two images. (a) approaching wave, (b) wave starting to interact with mesh, (c) wave energy dissipated by friction.

Wave fronts are dissipated as they pass through the structures, breaking up the coherence of incoming wave fronts (Figure 8a–c). This dissipation behaves as refraction through permeable structures. But the wave interaction can include a reflective component once structures have grown to be solid with all pores filled in, or if the rock fill is too impermeable to transmit wave pressure through intervening spaces. In that case, sand-eroding scour will be caused, while purely refractive dissipation increases sand accumulation underneath and behind the structure. There is also a diffractive component caused by wave interaction with the metal structure spacing and lattice spacing, which appeared to damp waves at spatial scales that range from the spacing of the metal grid used (0.1 m), the size of the modules (1–5 m), and the spacing of the modules (roughly 10 m).
